PYTHEAS GROUP

Surface Management

Brief Photo Report of C5–Marine Coating Implementation

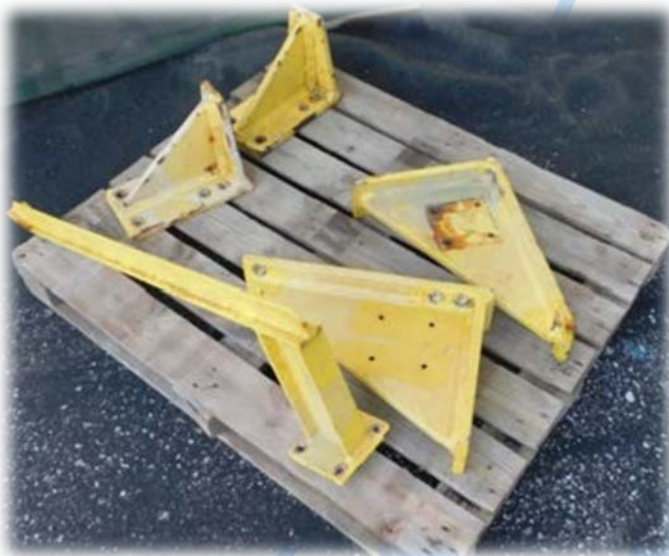
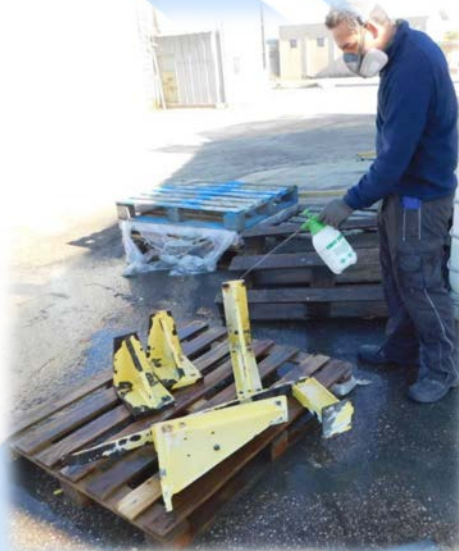
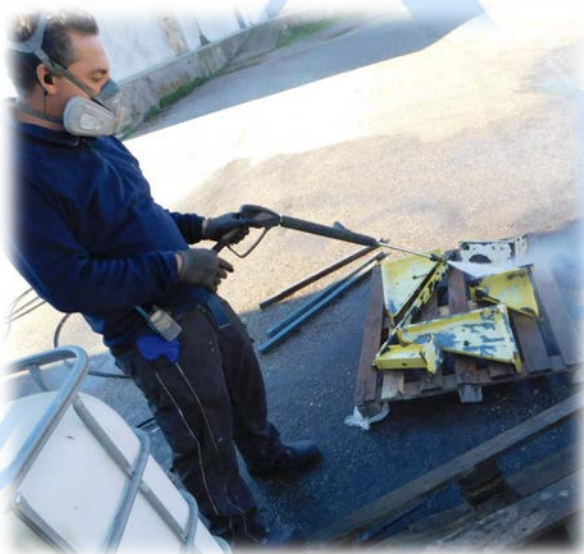
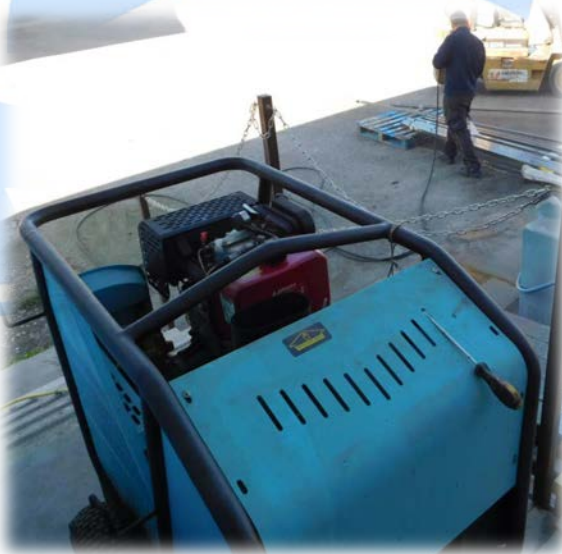
Stage One – Degreasing

Application of Alkaline Detergent followed by hot Pressure Washing at 200bars

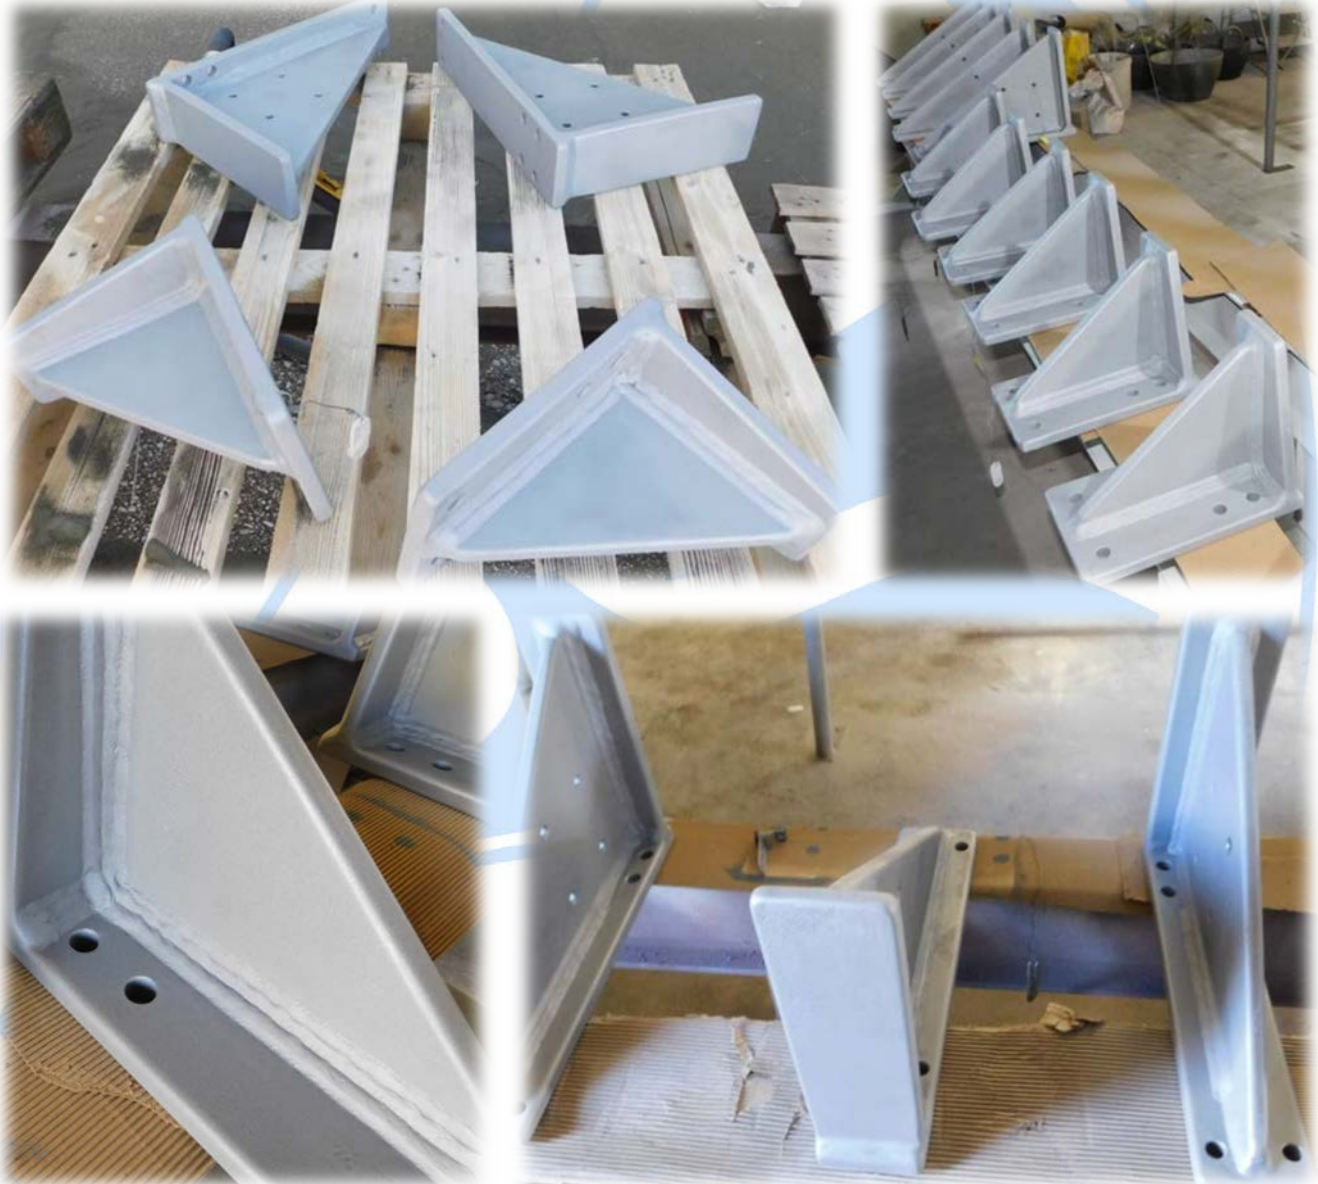
Stage Two – Sandblasting

- *Brand New Compressors Equipped with On-board Aftercoolers Guarantee that Blasting Air is Free of Oil and Humidity*
- *Certified Sibelco Blasting Media – Aluminum Silicate 0,2 – 0,6mm producing a Uniform Surface Roughness of 60μM – Metal Cleanliness SA 3.0*

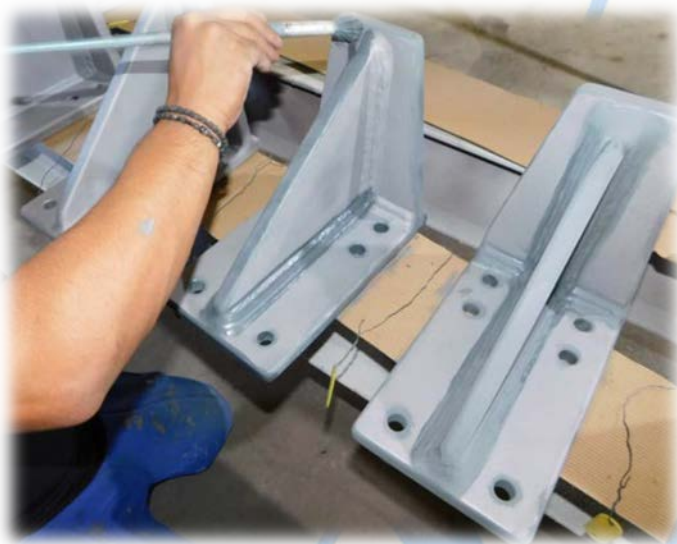
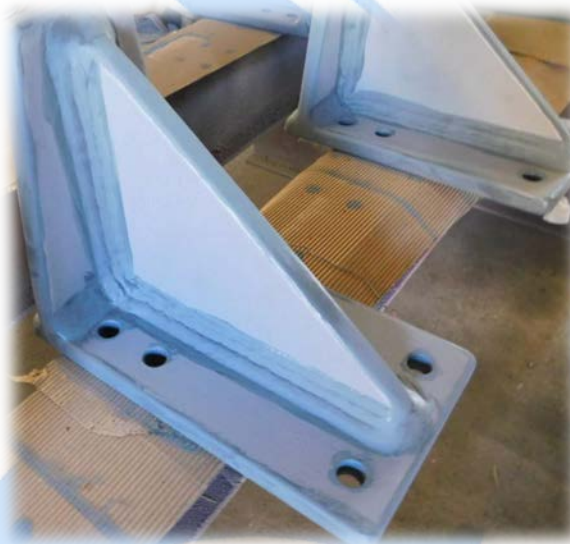
Stage Three – Bottom Coat

- *Environmental and Metal Surface Conditions are monitored and logged during all Stages along with Paint Data*
- *Bottom Coat starts with Stripe Coating of all Edges, Corners and Openings*

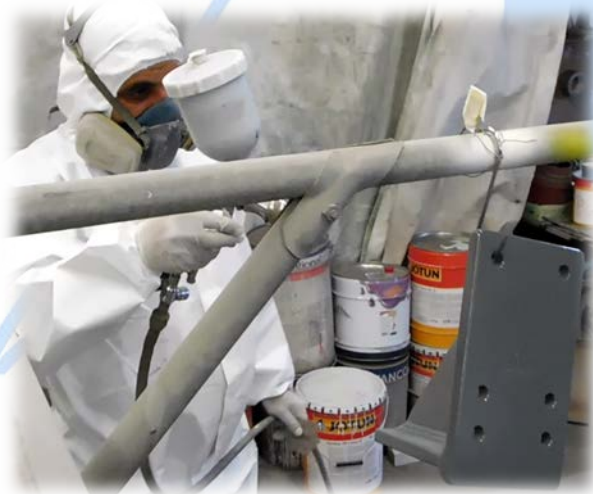
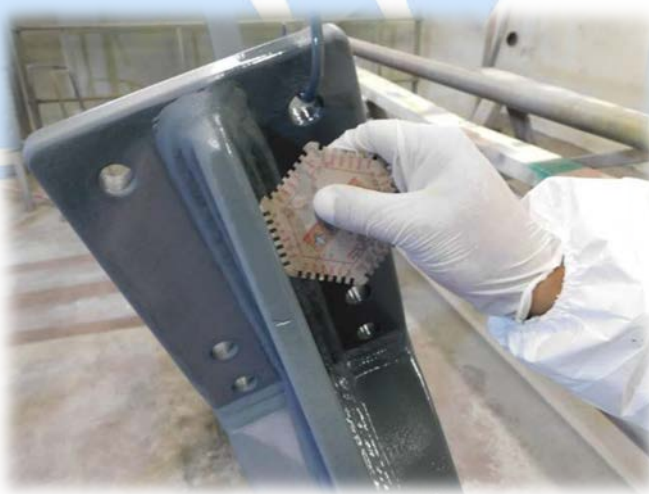
- *Followed by Spray Paint*
- *Wet Paint Thickness is monitored via certified Gauges*

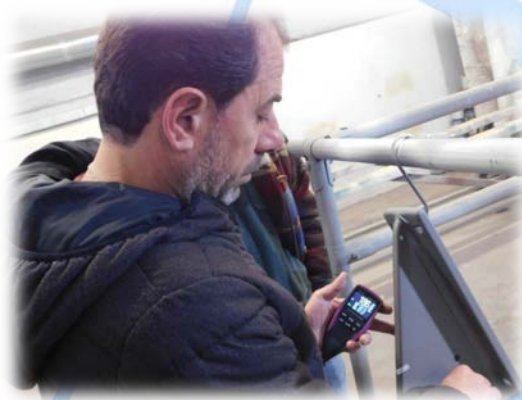
Stage Four – Consecutive Layers

- *Following the Completion of each Layer, the Dry Film Thickness is checked with a Digital DFT Gauge*

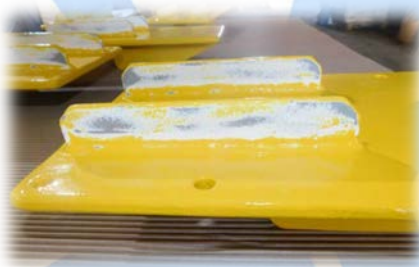
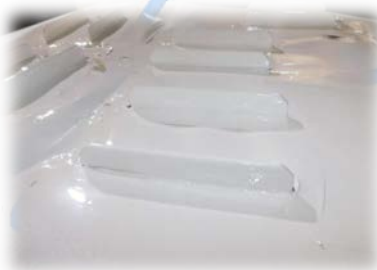
- *If the Readings are within Specs we move on to the next Layer*
- *If Thickness is lacking extra Paint is applied*
- *If Thickness is over the Limit, the overpainted Areas are marked and trimmed down*

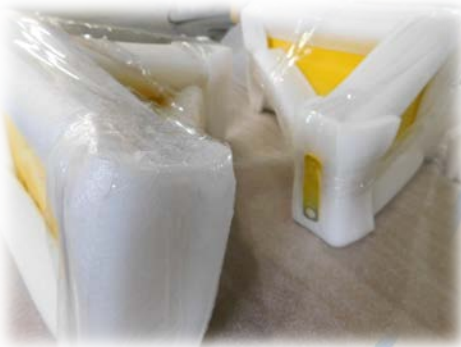
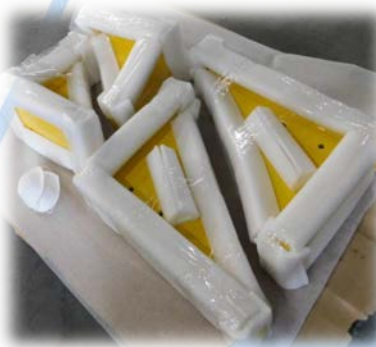
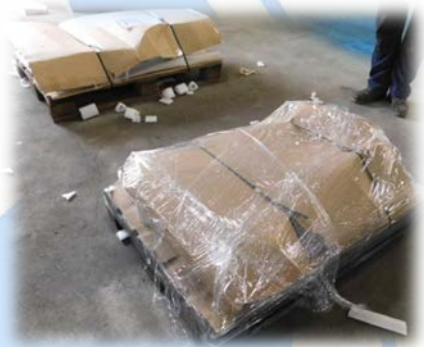
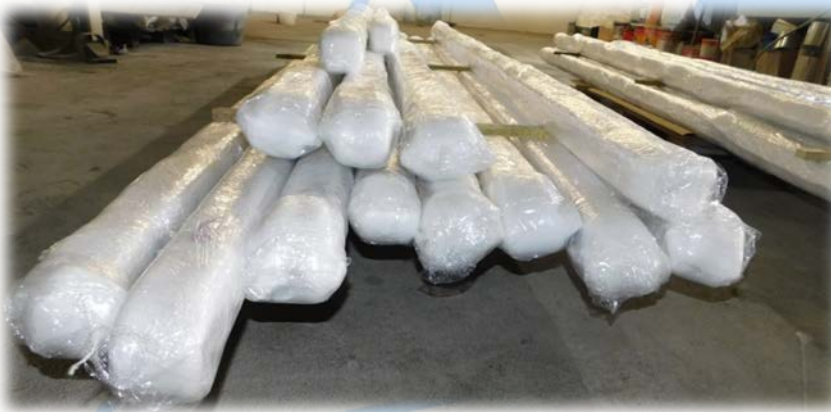
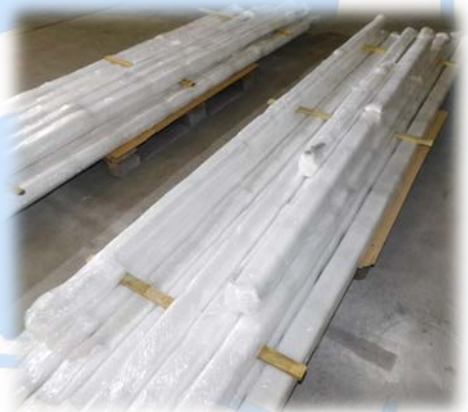
Stage Five – Packaging

- *Experience has shown that Coating Schemes are often damaged during Shipping thus greatly undermining the Longevity of the Protection System*
- *In order to minimize such occurrences and the Necessity of on the Spot Repairs we provide thorough Packaging*
